Follow-up case
Complutense de Madrid University.

Patient Description

1. Upper Full Arch restoration, four implants, position 1.3, 1.5, 2.3, 2.5, with multiunit abutment.
2. Mandibular Full arch restoration, six implants, position 3.1, 3.3, 4.1, 4.3, 3.6, 4.6

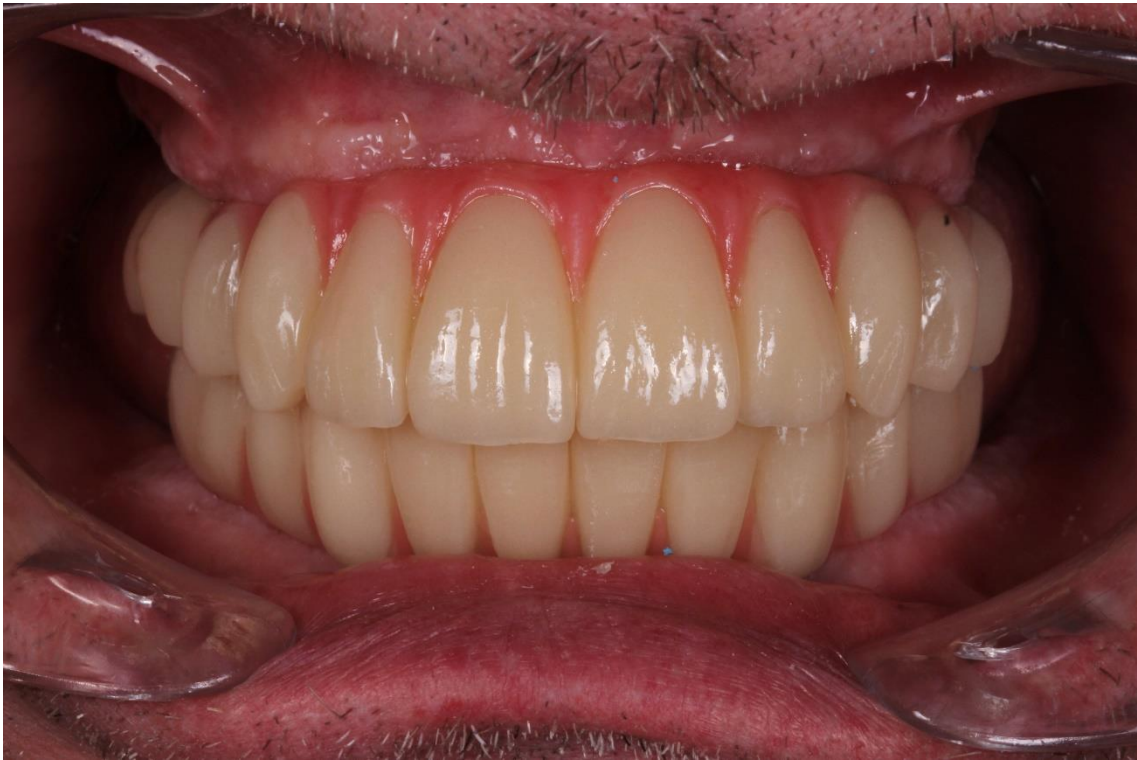
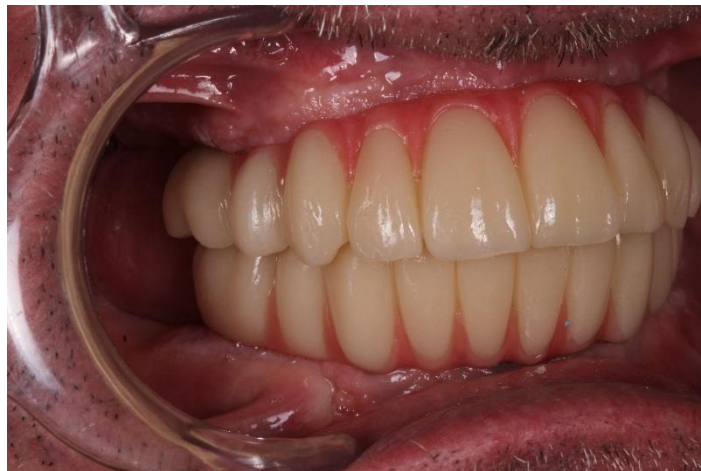
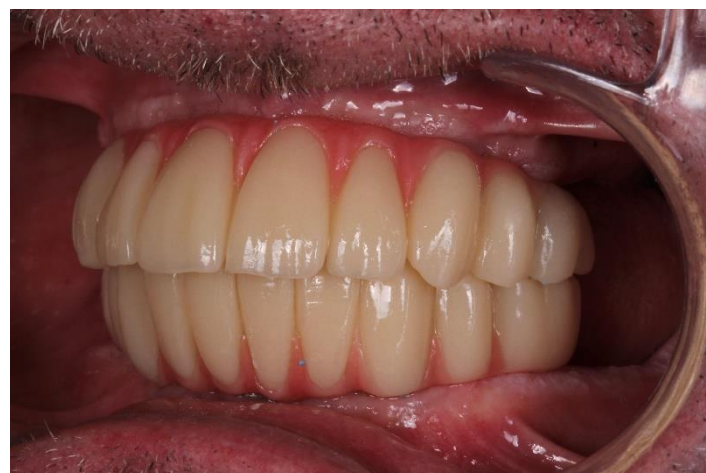
Definitive Prosthesis

Placement date 4/12/2019

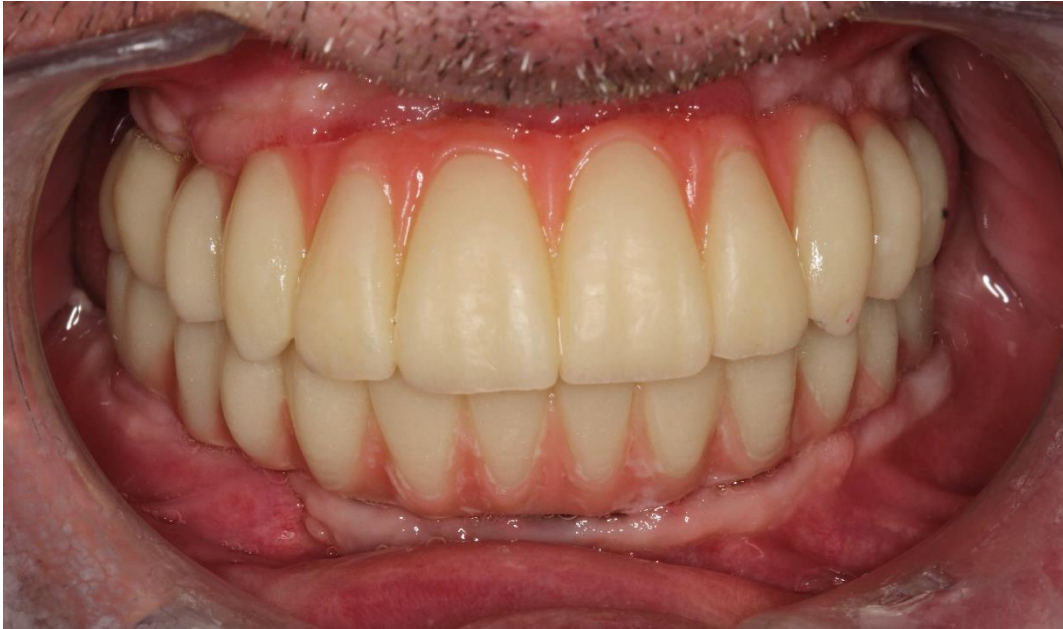
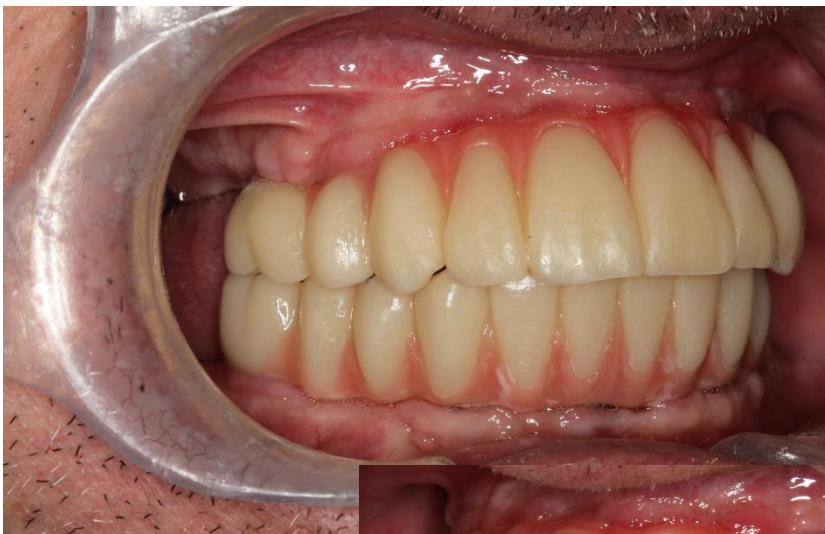
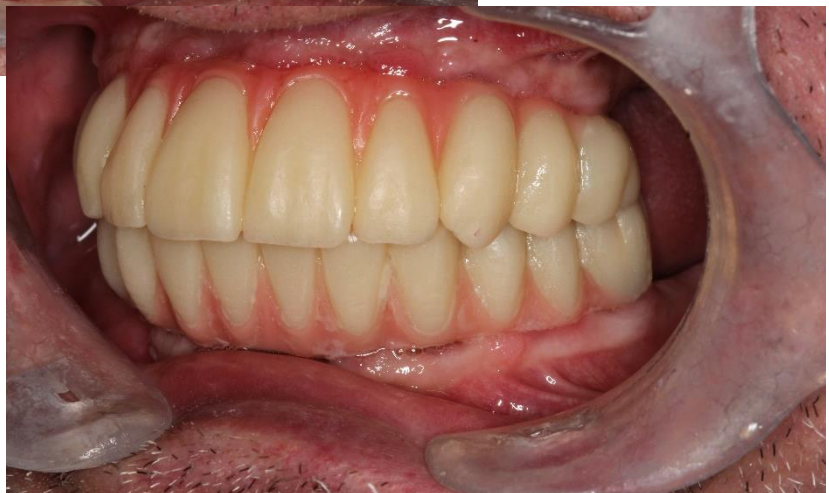
Definitive Prosthesis

Dental review 23/07/2019

Prosthesis review: occlusal check correct, good colour stability and not bacterial plaque.

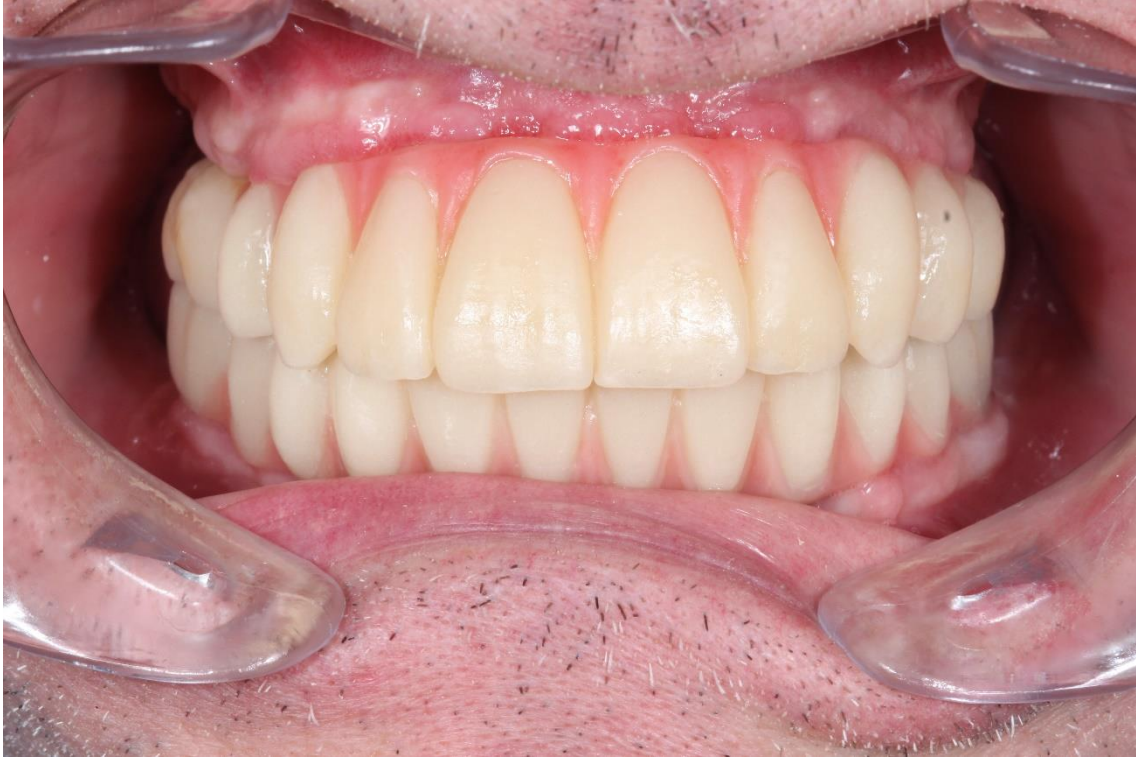
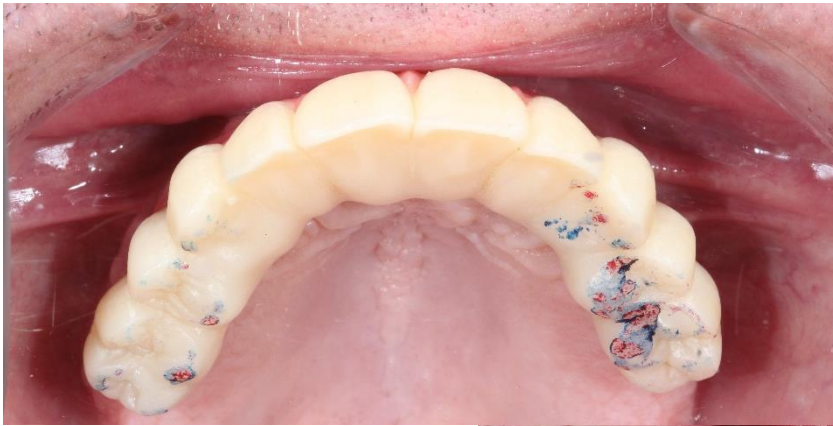
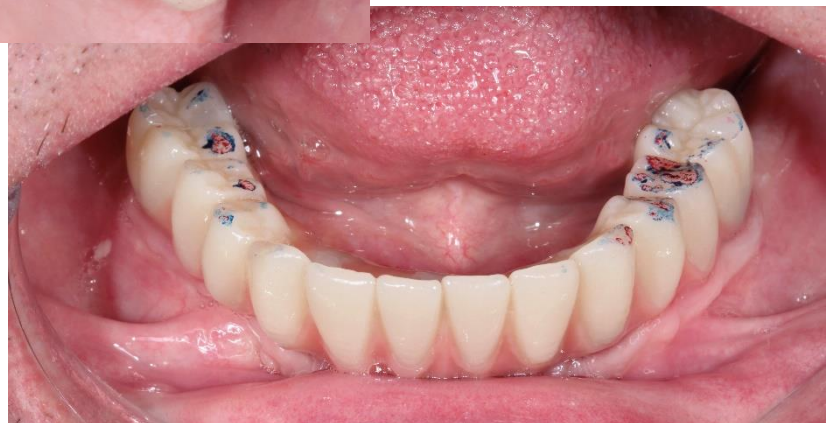
Definitive Prosthesis Dental review 10/03/2021

Prosthesis review: occlusal check correct, the colour is stable, not bacterial plaque and good hygiene. Prosthesis correct.
