PRESCRIPTOR	VICTOR HENAREJOS DOMINGO
PACIENTE (NHC)	<div></div>
LABORATORIO	GRAPHENANO DENTAL
ADJUNTO	FOTOGRAFÍAS + PDF

MARCA IMPLANTES	BIOHORIZONS
DIAMETRO	<p>Implante en 1.4 = 4.6 x 10.5 mm Tissue level (Plataforma 4.5 mm - verde)</p> <p>Implante en 2.4 = 4.2 x 12 mm Bone Level. (Plataforma 3.5 mm - amarilla)</p>
CONEXIÓN	<p>1.4= Plataforma 4.5 (verde)</p> <p>2.4= Plataforma 3.5 (amarilla)</p>
ADITAMENTOS	<p>1.4= ANÁLOGO DE 4.5 + INTERFASE</p> <p>2.4= ANÁLOGO DE 3.5 + INTERFASE</p>
SCAN BODY	<p>1.4= SCAN BODY DE BIOHORIZONS DE 4.5</p> <p>2.4= SCAN BODY DE BIOHORIZONS DE 3.5</p>
MODELO A IMPRIMIR	SÍ

1. **Final Prosthesis to be performed:** Screw-cement Implant prosthesis 1.4 and 2.4
2. **Material:** Graphenano Dental (G-CAM)
3. **Comments:** Final colour A3. Characterization of periodontics teeth and fine occlusal stain.

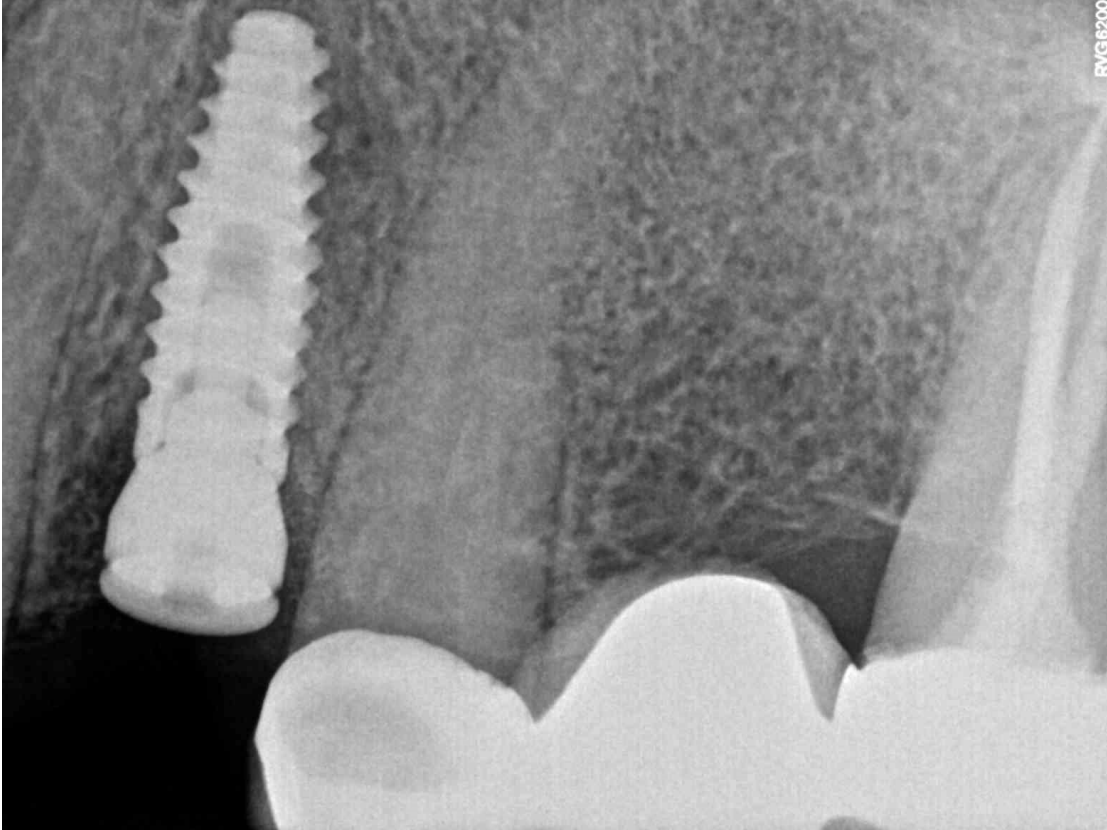
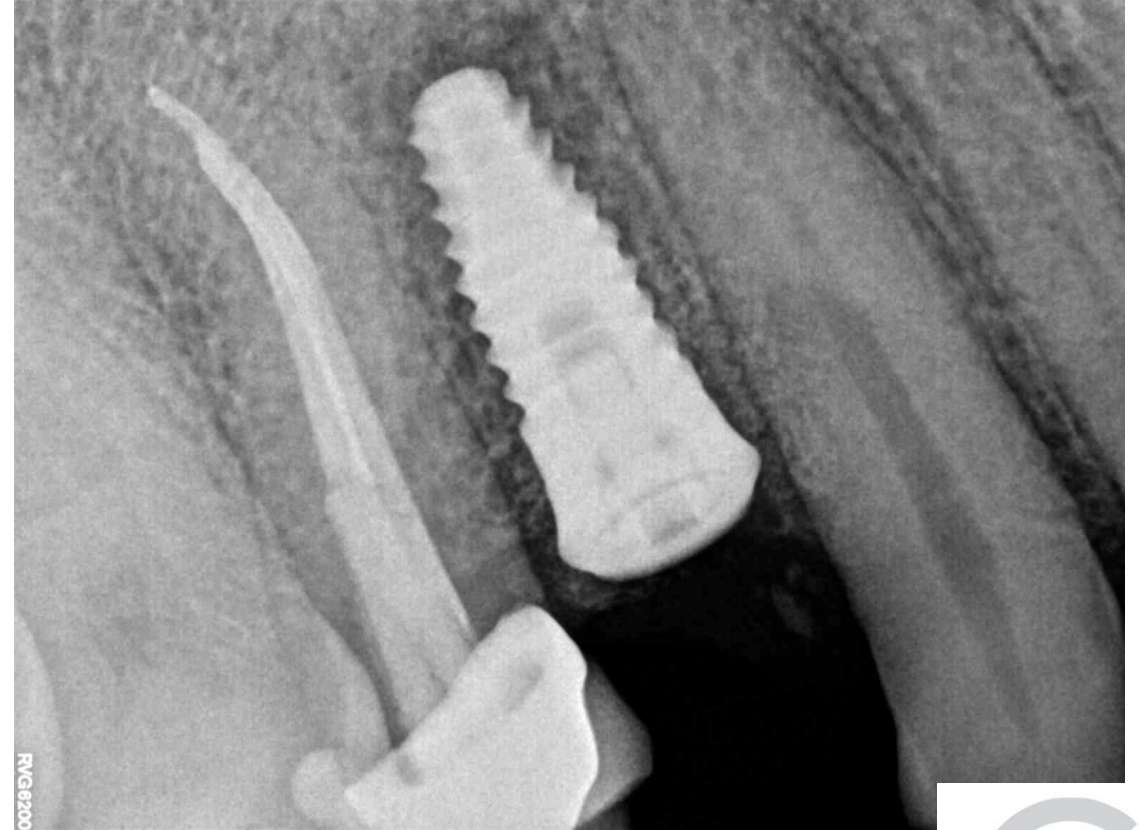
# X-rays after implant placement.

Placement date 27/07/2020

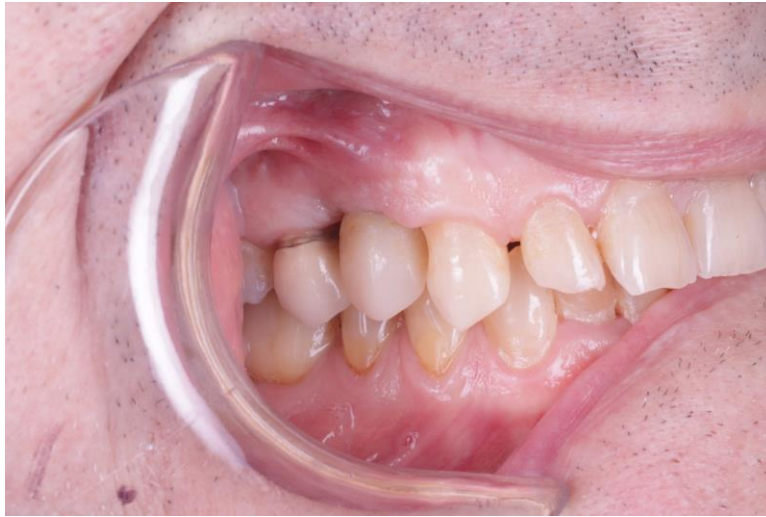
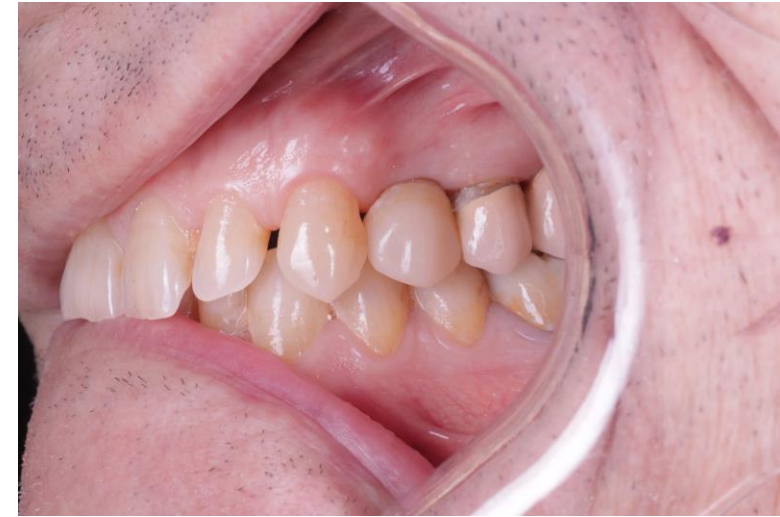
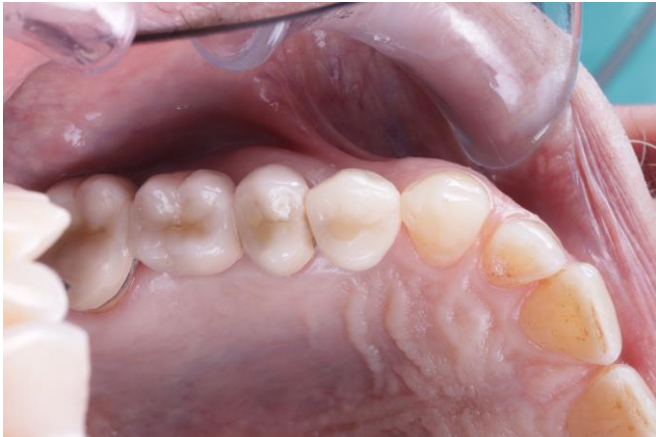
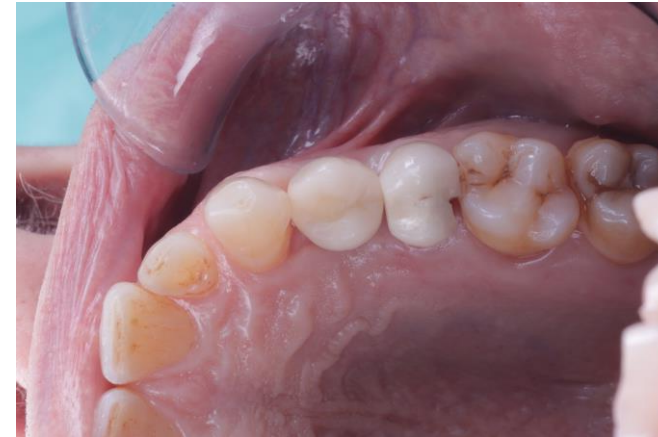
# Definitive Prosthesis

We check the occlusion and the color.

The two implants crown are correct according to the specifications requested from the laboratory.

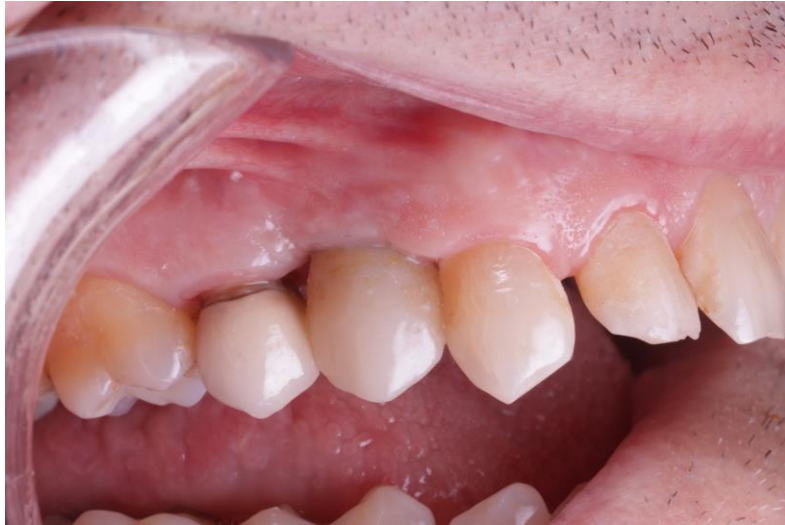
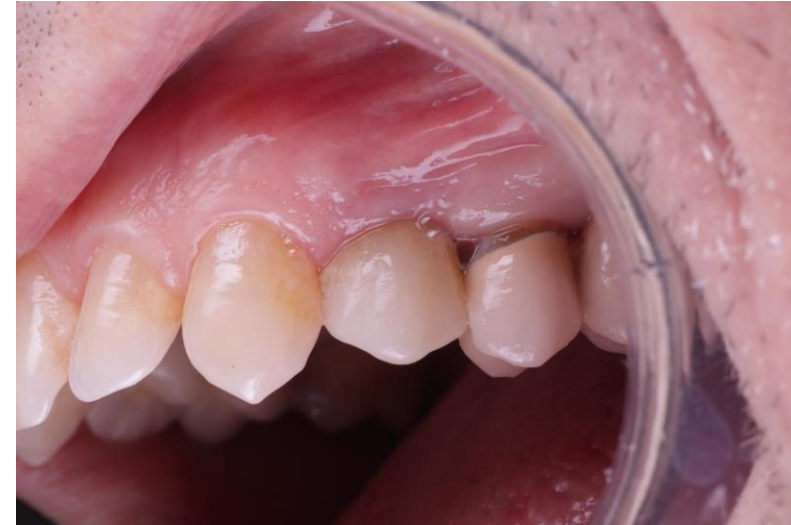
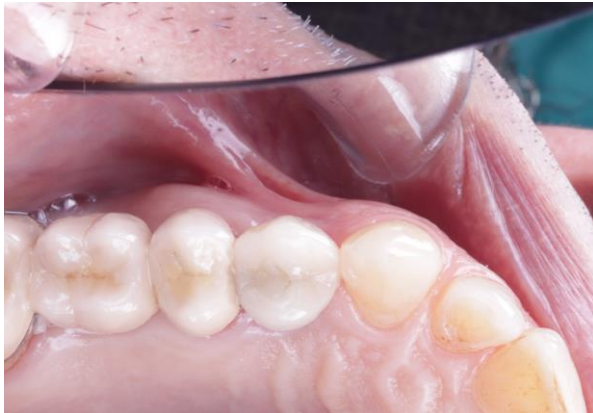
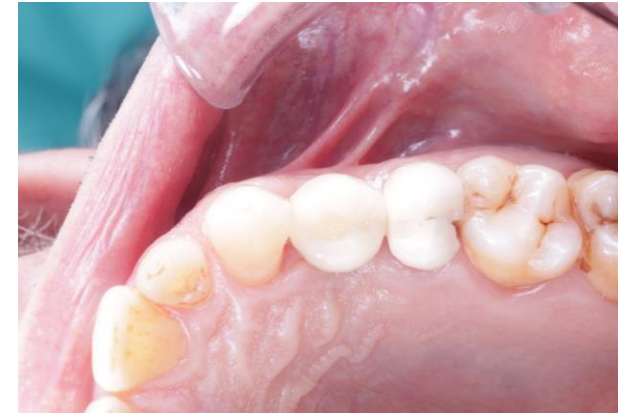
# Definitive Prosthesis

First review: check the occlusion, color and dental hygiene.

After these months, we observed that the two implants crowns remained stable in occlusion, not observed bacterial plaque or occlusal wear.
